Manhole Inspection Summary

Manhole # S41A__035MH

Location Address: **Dunbar High School Parking lot**

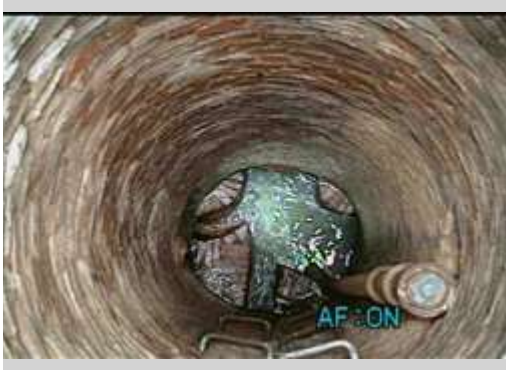
Top View

pipe @3

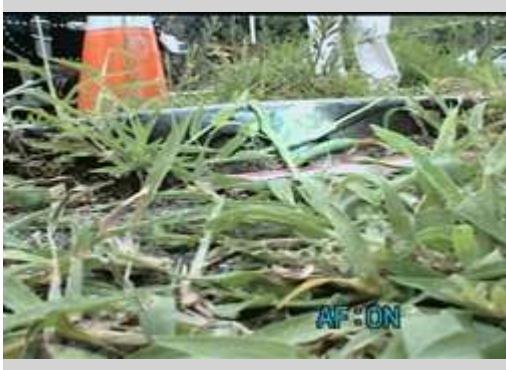
Defect 3

Diameter: **25.** (in.) Length: **0** (in.) Dist A/B Grade: **2** (in.)
5

above grade

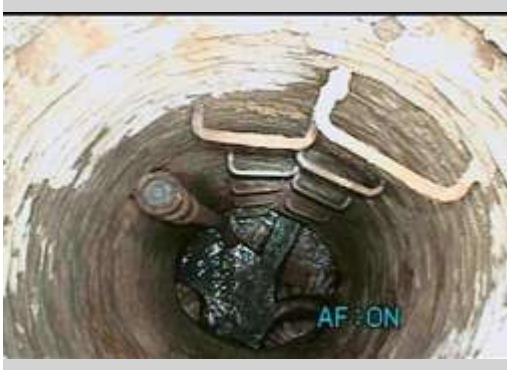
Defect 2

Count: **10** Missing: **0** ☒ **Corroded**

steps

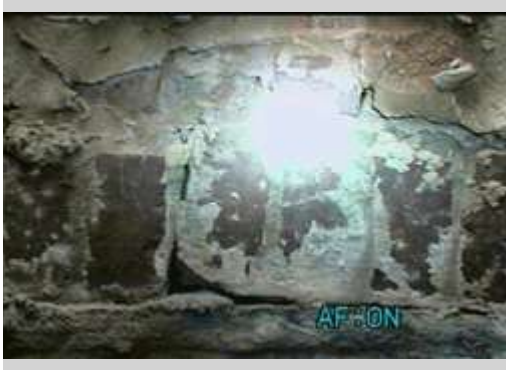
Condition: ☐ Sound ☒ **Cracked** ☐ Root Intrusion ☒ **Loose Brick** ☐ Deteriorated

chimney loose bricks, cracked, frame adjustment

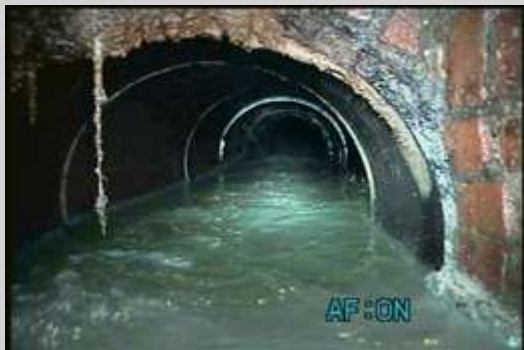
12 O'Clock Outflow

8 in. Circular Gravity Sewer
Pipe Out @ 12 O'Clock

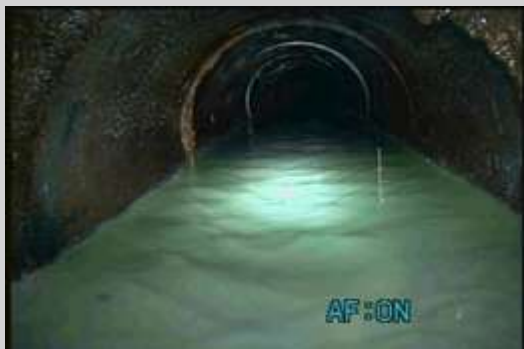
3 O'Clock Inflow

8 in. Circular Gravity Sewer
Pipe In @ 3 O'Clock

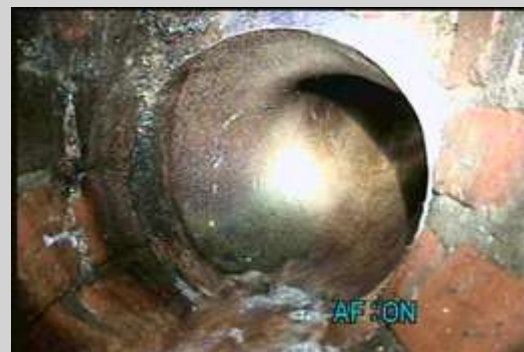
Drop In @ 9 O'Clock

Drop: Outside Direct
